**SUBJECT: Campaign #101 - Sightseer® and Sunova® Range Cabinet Partition**

## INSTRUCTIONS TO PERFORM CAMPAIGN 101 RANGE CABINET PARTITION

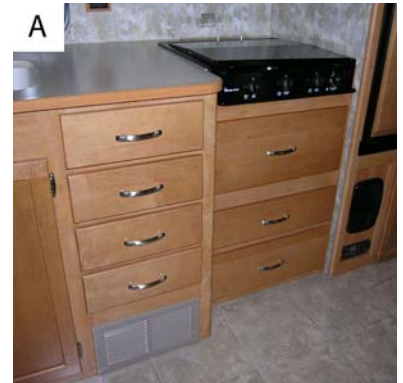
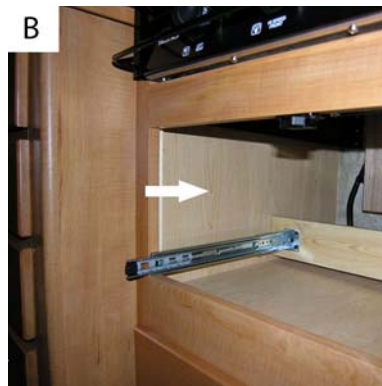
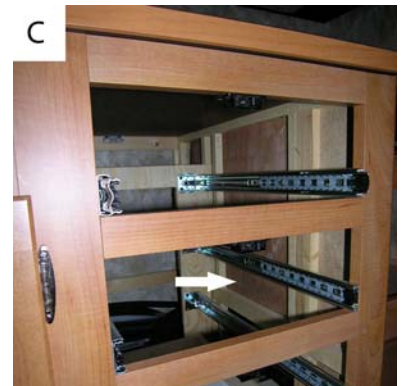
1. If you have a stovetop only model, remove the drawer beneath the stovetop. (A drawer replaces the oven in stovetop only models.) If you have a stovetop with an oven model, remove the drawers to the left of the oven.
2. Look for the panel shown in photo B (stovetop only) or photo C (stovetop with oven). If the panel is already installed, you can reinstall the drawer(s) and no further action is required. If the panel is missing, proceed to step 3.

The procedure involves inspecting the cabinetry to assure a vertical panel is installed. If the panel is missing, one must be installed.

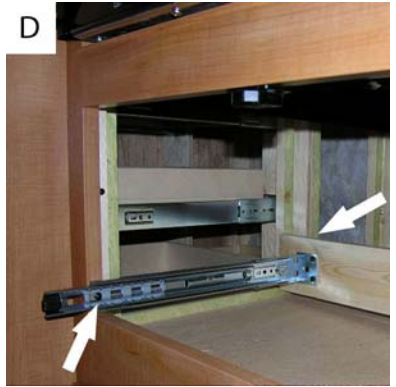
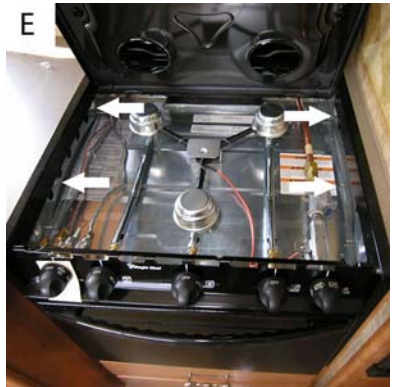
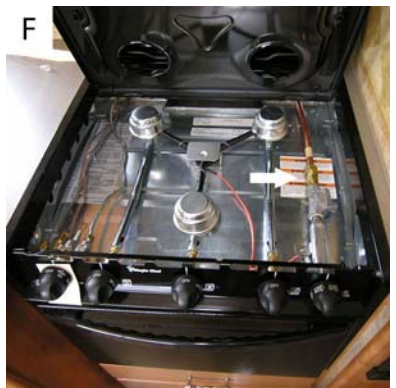
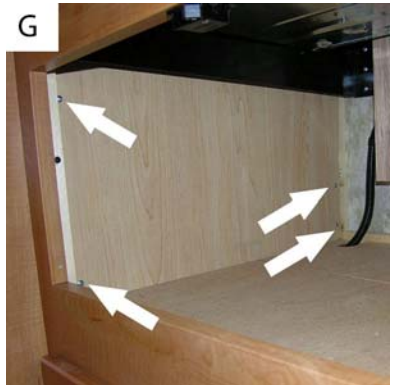
3. If you have a stovetop only model, remove the screws attaching the drawer slides to the side of the cabinet and the screws attaching the backsocket frame to the cabinet (shown in photo D). Remove the drawer slide assembly from the cabinet.

- Turn off main propane supply at the tank.
  - Lift top of stove.
  - Remove the stove mounting fasteners (2 screws each on left and right sides- photo E) and then disconnect the gas supply line from the burner regulator (shown in photo F).
  - Lift out from cabinet and set aside.
4. Cut a panel to the size of 21 1/4" x 16 5/8" (541mm x 422mm)
  5. Install the panel to stickwork along left side of the cabinet with the #10 screws (shown in photo G). Assure that there are no gaps that will allow air exchange.
  6. If you have a stovetop only model, reinstall the drawer assembly and the drawers.  
If you have the stovetop with oven model, reinstall the oven and drawer.
  7. If the propane supply line has been disconnected, perform a propane gas leak test.
