SUBJECT: Campaign #103 –TV STRAP BOLTS

INSTRUCTION TO PERFORM CAMPAIGN #103

INSTRUCTIONS TO PERFORM CAMPAIGN 103 TELEVISION STRAP BOLTS

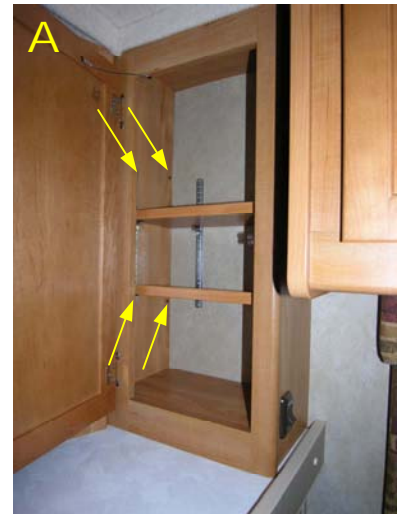
1. Remove the shelves in the cabinet to the right of the television. Unscrew the left side panel in the cabinet. (Photo A)

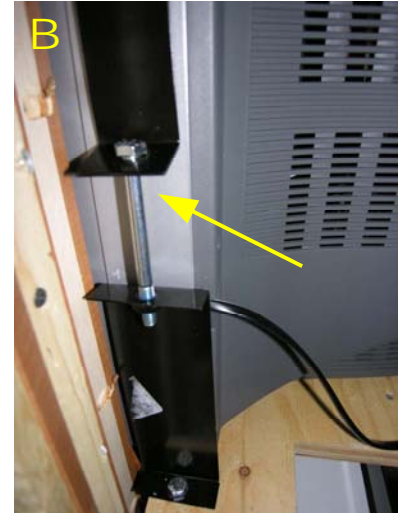
2. Inspect the bolt holding the straps together on the right side of the television. You may want to use a mirror and flashlight to easily see the bolt. (Photo B)
 - a. If this bolt has blue thread lock compound, you may stop. You will not need to perform the campaign. Reassemble the cabinet and submit for inspection only.
 - b. If this bolt does not have blue thread lock compound, you will need to replace all three bolts securing the strap. Continue to Step 3.

4. Remove the bolt holding the straps together on the right side of the television. (Photo B)

14. Fasten the straps together with the new 4" bolt. (Photo B)
 - a. Hold the lower strap so it will not turn and cause harm to the television casing.
 - b. While tightening the bolt, ensure the strap is tight, but not to the point of causing damage to the television.

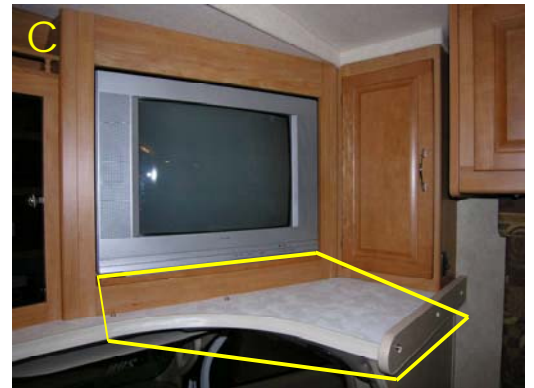
3. Protect the bottom edge of the television cabinet and surrounding areas with masking tape and carpet squares, or equivalent. (Photo C)

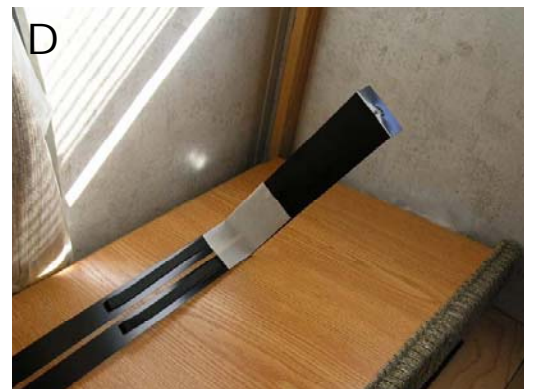
7. Cut the 12" piece of adhesive into two 6" pieces. Remove paper from one side and place adhesive in the corners of the strap. If there is foam tape in the way, cut away the interfering sections. A typical strap has been shown in the picture. (Photo D)

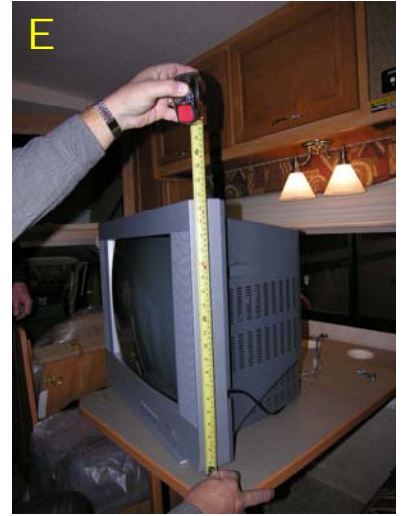
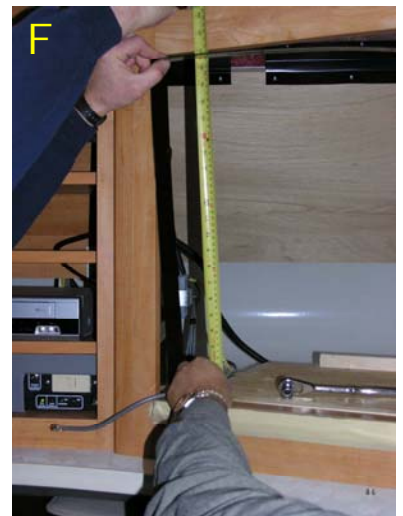
9. Measure the television from the base to the top to ensure proper height for the left strap. (Photo E)
10. Reinstall the left side of the strap with the new 3" bolt. Position it so the top inside corner of the strap is the same height as the television. (Photo F) Make sure to bolt it through the original hole to ensure proper fit.
