SUBJECT: Campaign #106 – Windshield Wiper Linkage

The motor vehicles potentially containing the defect are on certain 2008 model year Winnebago Adventurer® and Itasca Suncruiser® motor homes built prior to July 10, 2007.

INSTRUCTIONS TO PERFORM CAMPAIGN 106

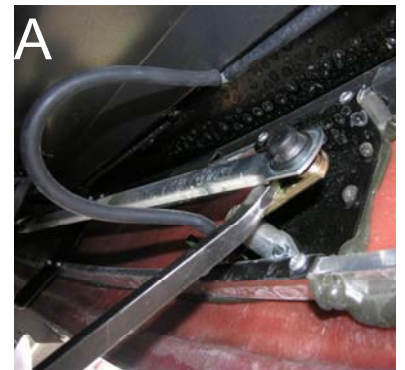
1. Open front hood by squeezing latch handles toward hood panel and raise hood into open position.
2. Remove wiper link arm from ball stud on the pivot assemblies at the driver and passenger side wipers by using a pry bar. See Photo A.

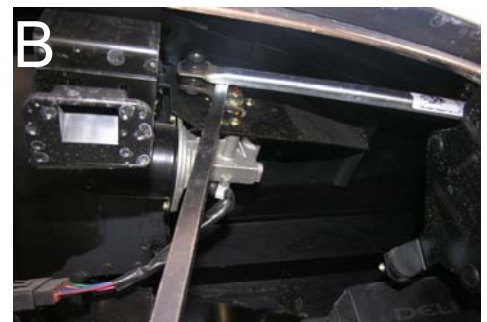
3. Remove driver and passenger side wiper link arm from the ball stud at the motor drive arm by using a pry bar. See Photo B.

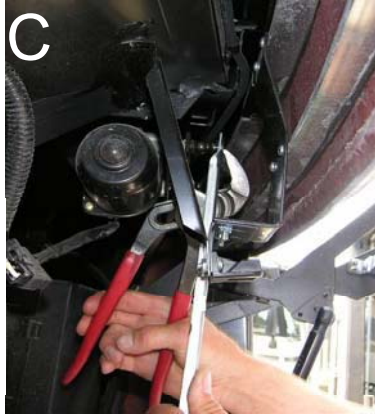
- Using a channel lock pliers, install the driver side wiper link arm (the shorter link) first on the driver side pivot assembly and then to the inside ball of the wiper motor drive arm. See Photo C.

NOTE: If the ball stud is dry, apply a small amount of multipurpose grease to ease installation.

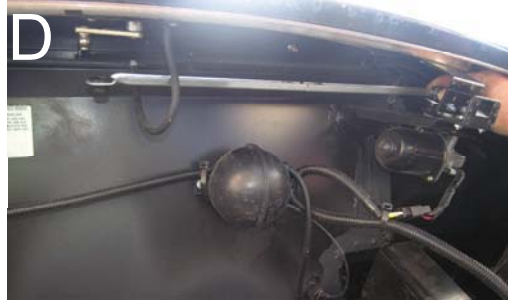
Install the passenger side wiper link arm (the longer link) first to the outside ball of the wiper motor drive arm and then to the passenger side pivot assembly. See Photo D.

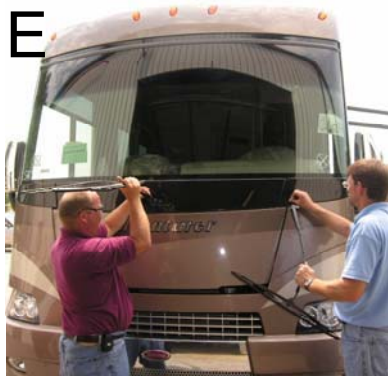
- Close hood by lowering into latched position.
- Remove driver and passenger side wiper arms. See Photo E.

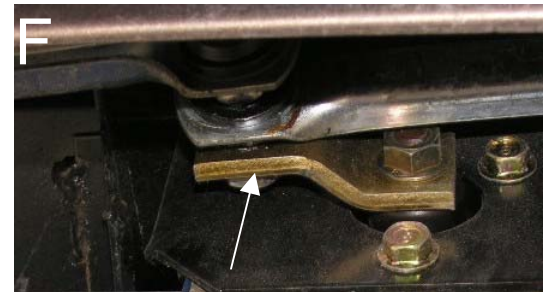
- Start the engine and cycle the wiper motor making sure to allow the wiper motor to come to a stop in the “park” position prior to turning off the engine.
- Open the hood and inspect the wiper motor. The wiper motor drive arm must be at a 9 o'clock position. Shown in Photo F.

NOTE: If the wiper motor drive arm is not at a 9 o'clock position, repeat Steps 7 and 8.
