TO: Winnebago Industries, Inc. Dealers

SUBJECT: Campaign #107 – Itasca Suncruiser® and Itasca Ellipse® Reflectors

INSTRUCTIONS TO PERFORM CAMPAIGN 107

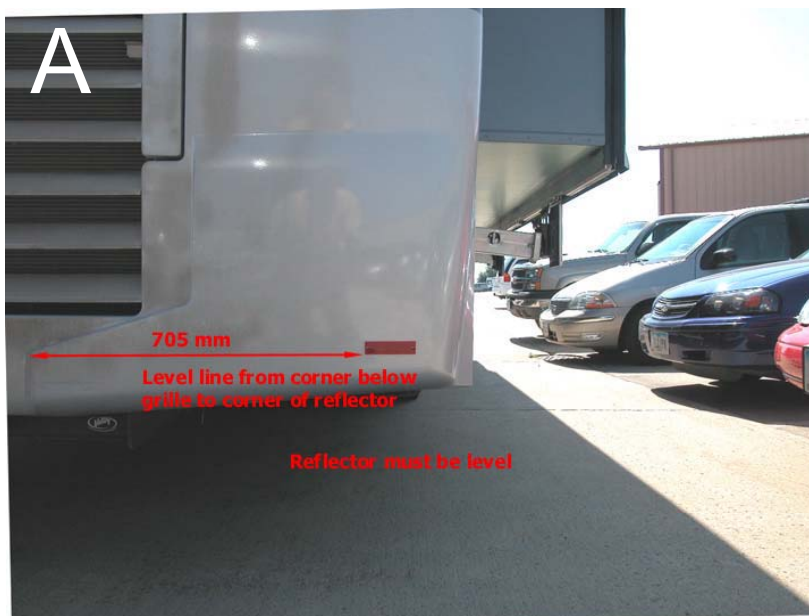
1. Remove the self-adhesive backing strip on the back side of the reflector and position 705 mm out from the angled inner-most corner below the rear grille. Reflector must be level. See Photo A.
2. Using a screw gun with a #2 Phillips tip, insert the black screw into the reflector hole and install screw until almost seated. Finish installing screw by hand with a Phillips screwdriver to ensure that overtightening does not occur. Install second black screw into opposite side of reflector.

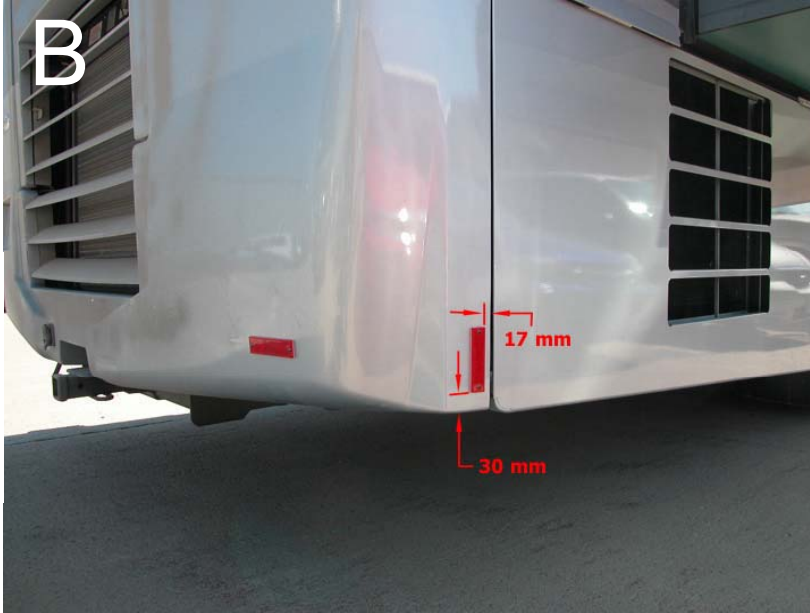
3. Remove the self-adhesive backing strip on the back side of the reflector and position 17 mm in and 30 mm up on the rear backcap. See Photo B.
4. Using a screw gun with a #2 Phillips tip, insert the black screw into the reflector hole and install screw until almost seated. Finish installing screw by hand with a Phillips screwdriver to ensure that overtightening does not occur. Install second black screw into opposite side of reflector.
