SUBJECT: Campaign #112 – Propane Tank Bracket

INSTRUCTION TO PERFORM CAMPAIGN # 112

INSTRUCTIONS TO PERFORM CAMPAIGN 112

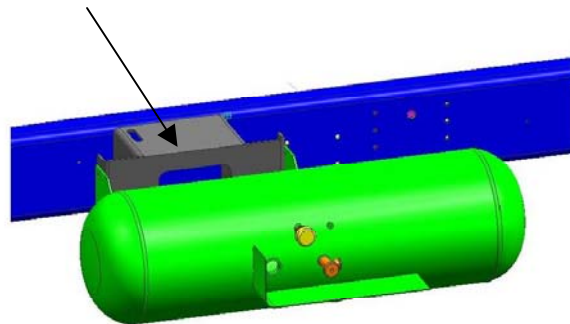
LP Mounting Bracket

Inspect the LP tank mounting bracket for incomplete or improper weld.

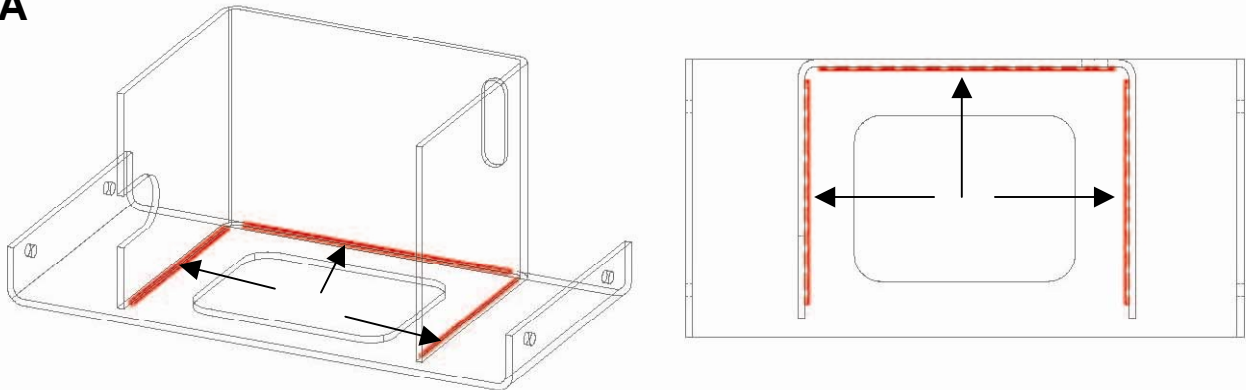
A

4. Go beneath the vehicle to inspect the welds of the bracket assembly. The welds should be placed in the position and manner shown in red. See Photo A.

Welds shown in red above

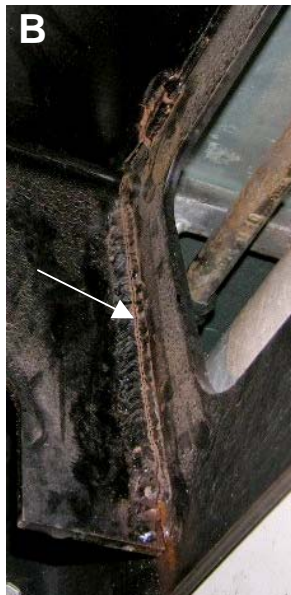
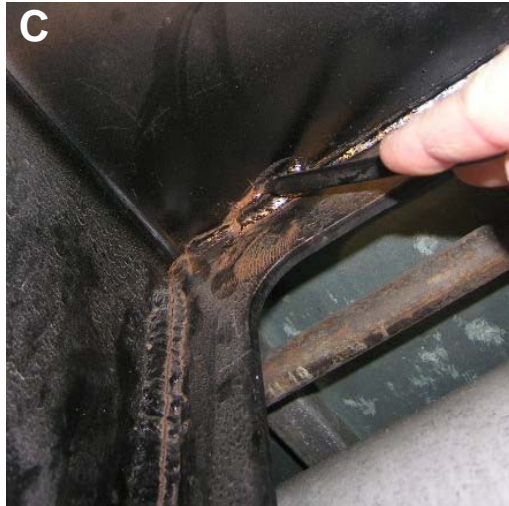
5. Inspect the welds for cracks, rust, or gaps between the weld and plate. See Photos B and C as an example of improper weld penetration, cracking, and fatigue.

6. Using a ball peen hammer (welding hammer) or similar tool, test the surfaces of the bracket by using the hammer to impact the surfaces to assure the bracket welds are proper and the bracket is firmly attached to the chassis rail.

Should the welds show any signs of failure, contact the Winnebago Industries Technical Service Department at (866) 653-4329. Winnebago staff will work with your dealership in order to complete repairs.
